# *Topsham Fair Mall Stream Watershed Based Plan*

*April 2014*

Prepared by **FB Environmental Associates**

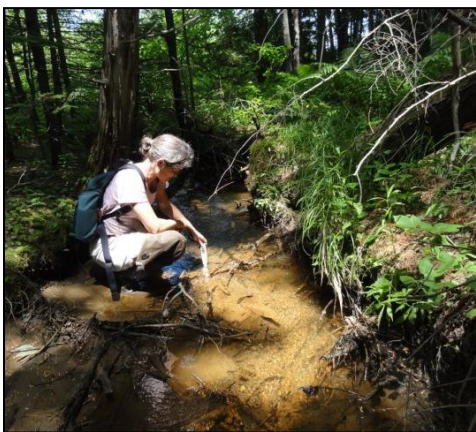
*Figure 1: Monitoring by Maine DEP has indicated water quality impairment in the stream. Photo: K. Feindel.*

*Topsham Fair Mall Stream Water Quality Assessment:* Sampling data were collected by Maine DEP in 2002, 2006 and 2008 which included monitoring of the macroinvertebrate community, physical habitat parameters and water chemistry. Sampling results were compared to Maine's statutory Class B water quality standards and the stream was listed as impaired due to non-attainment of aquatic life criteria and for non-attainment of habitat assessment (Maine DEP, 2011a).

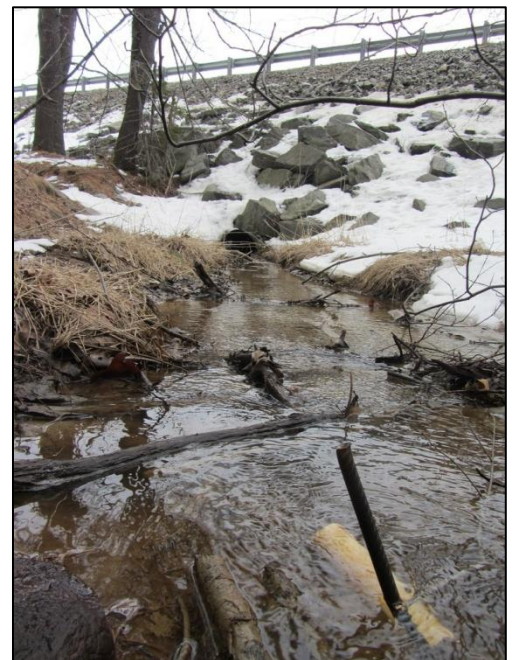
Figure 8: Water quality monitoring indicated high salinity from road salt in both winter and summer conditions.

The monitoring data clearly indicate that chloride is a pollutant of concern in Topsham Fair Mall Stream throughout the year. Chloride concentrations in the middle and upper portion of the stream are constantly above the chronic pollution threshold of 230 mg/L during summer baseflow periods, and nearly so in winter. In the winter, they are over the acute threshold of 860 mg/L about 2% of the time, coinciding with salt application during storm periods. Chloride concentrations are much lower in the downstream reaches, with water quality exceeding chronic standards about one third of the time in winter, acute standards about 1% of the time in winter, and water quality in compliance during the summer baseflow period.

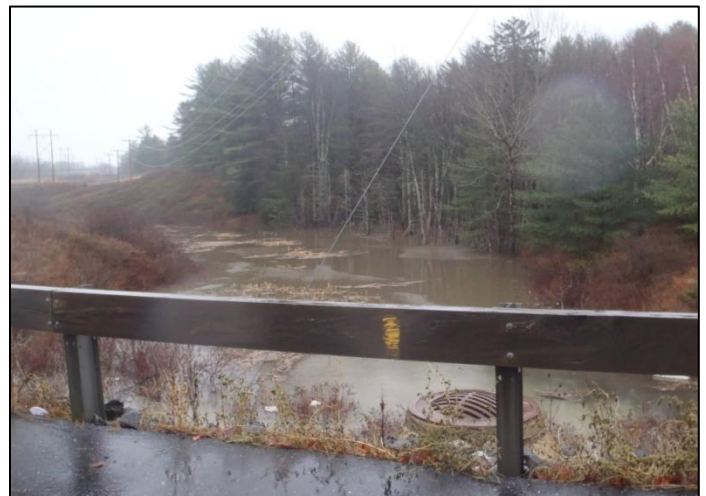
*Figure 12: Stormwater detained behind the Midway Drive road crossing. (C. Rinehart, Wright-Pierce).*

Specific symptoms of poor habitat were identified in the geomorphic assessment. Upstream of the culverts, there tends to be marshy floodplain with poorly defined, multiple channels, and downstream of the culverts the stream channel is incised. The few areas of potentially good, meandering aquatic habitat suitable for trout and other aquatic life are therefore too small and isolated from each other to support the minimum aquatic life required by state standards.

In addition to impairing habitat, the massive amount of fill which is blocking the floodplain at each road crossing creates a serious flood hazard potential. If any of the seven small culverts ever become plugged during a storm, there is a risk that the floodplain will fill with water, overtop and cause a cascade of road washouts which would threaten life and property.

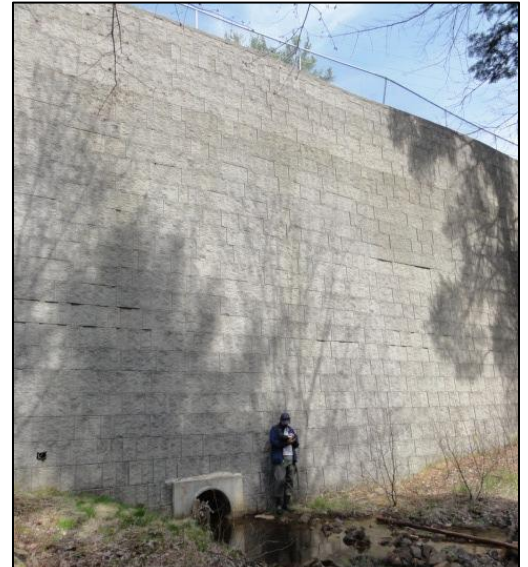
Figure 13: Retaining wall and fill, with small culvert for stream, blocking the floodplain beneath a road crossing. Photo: K. Feindel, Maine DEP.

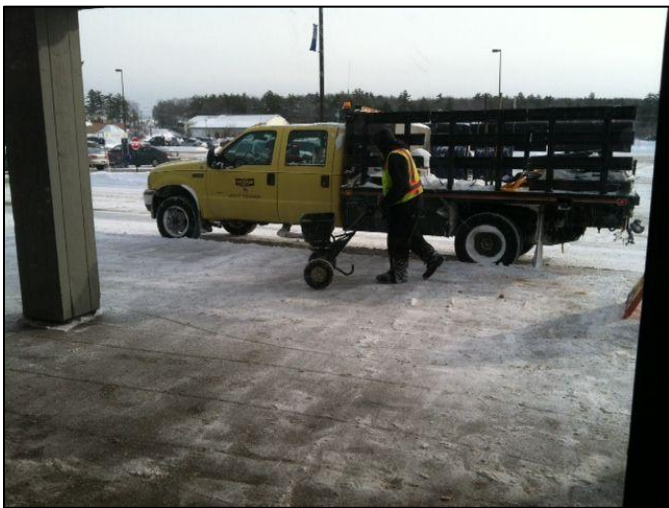
Figure 14: Heavy salt application can cause high chloride levels in both winter from direct runoff, and in summer due to groundwater contamination.

The geographic and temporal patterns of chloride concentrations in the Topsham Fair Mall Stream strongly suggest that de-icing salt applied to parking lots and roads in the upper and middle watershed is entering the stream through two pathways: runoff and groundwater. Direct runoff can occur when salty melt water (or excess rock salt) flows directly to the stream overland or through stormdrains, and when salt-laden snow is dumped next to a stream and then rapidly melts. Highly salty runoff creates an extremely large spike in chloride concentrations which causes in-stream conditions to rise above the acute water quality standards for a period of hours or days.

Groundwater, a second pathway by which chloride enters the stream, occurs as salty melt water gradually seeps into the ground (via the surface or through leaking stormwater pipes), and then is gradually released into the stream over a period of months or years. Salty groundwater is indicated by higher chloride concentrations during the stream's low-flow periods in the late summer and fall, interrupted by a temporary decline during storms when rain provides in-stream dilution. Based on limited monitoring during this study which indicated low chloride levels downstream, it appears that contaminated groundwater is localized in the upper and middle watershed where commercial development is most intense and has been around longer, and there are very high levels of impervious surfaces.

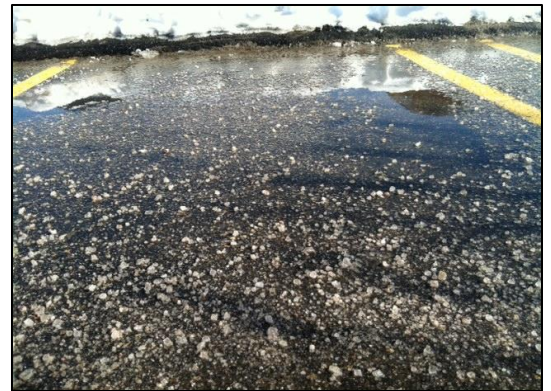
*Figure 17: Rock salt applied to a watershed parking lot. Photo, J. Edgerton.*

There is a clear need to reduce chloride loading in the Topsham Fair Mall Stream. An estimate of how much salt reduction is needed can be a valuable aid in stream restoration planning. There has been an intense data collection effort aimed at chloride in the past two years by Maine DEP and FB Environmental. These data clearly show that chloride levels spike far above the acute water quality standards during winter storms. They also show that chloride levels remain above the chronic water quality standard for weeks at a time in both winter and summer. Still, it must be acknowledged that this relatively brief data collection period cannot fully account for variations in storm conditions and salt application patterns from year to year. Ongoing sampling will be needed to quantify with greater certainty chloride dynamics in the watershed.

Using the available data, correlating specific conductance levels to chloride grab samples in Topsham Fair Mall Stream taken in winter and summer in 2013 ( $n=10$ ,  $r^2=0.89$ ) provides an initial estimate of chloride levels during two data sonde sample periods. Chloride levels were highest in the middle reach of the stream (sample site TMD, Midway Drive crossing) during winter and summer. The peak one-hour average chloride concentration at this site was estimated to be 3,644 mg/L during the winter storm of March 20, 2013. From that concentration, meeting the acute water quality standard of 860 mg/L would require a 76% source reduction. Similarly, during the period of August 16 to 27, 2013, the maximum four-day average chloride level was estimated to be 328 mg/L, compared to the chronic water quality standard of 230 mg/L, which suggests a 43% reduction would be necessary to meet the standard. These data are merely preliminary, and further sampling is needed to determine if they are typical, yet they provide a starting point for planning purposes.
